# Safety Inspection Report

Annual Inspection

## Church View Play Area

Stibbard Parish Council

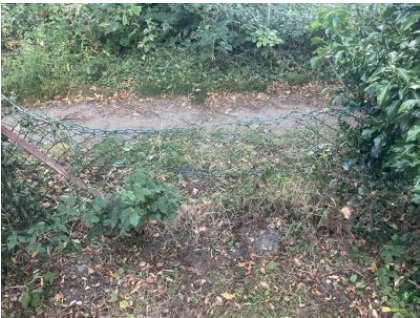
| Description |
|---|
| Monitor. |
| Monitor damage to the chain link fence. Repair as required. |

| Description |
|---|
| Read the notes for further action. |

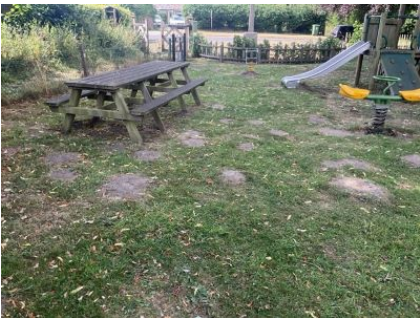
Mole hills present.

Eliminate.

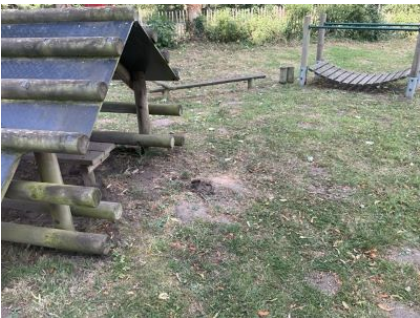
Suitably well maintained grass and topsoil with at least 150 mm of soil beneath is acceptable to EN 1176 for items with a fall height of up to 1.5 metres, subject to a risk assessment.

Monitor to maintain the grass in good condition.

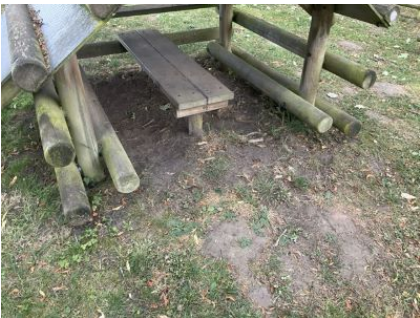
Worn ground areas.

Consider installing grass mats to help with wear.

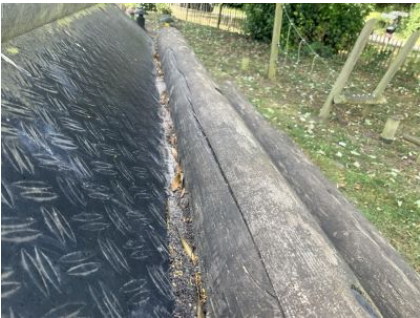
There are natural splits / shakes in the timbers.

Shakes vary. Monitor and consult manufacturer if dimensions exceed 8 mm at sections used to grip / grasp., DO NOT fill shakes. Monitor and sand back any splintered edges as required.

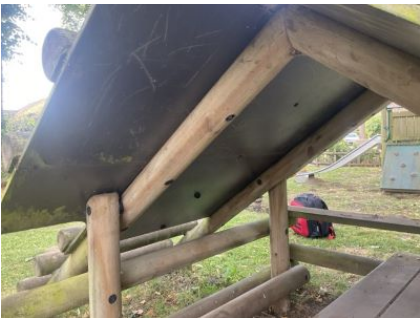
Cap missing.

Replace.

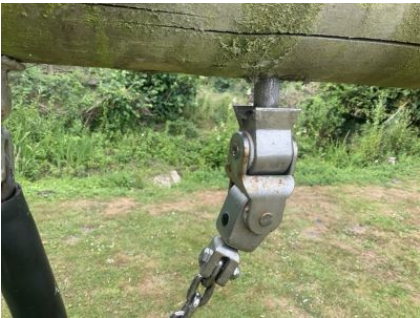
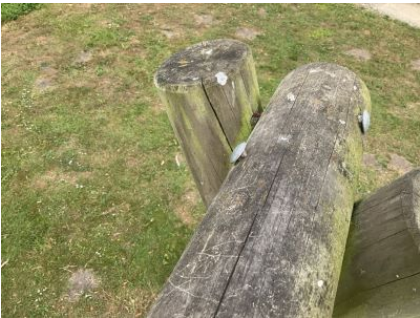
Bolt(s) loose.

Swing hanger x 1 and crossbar bolt x 1 loose.

Tighten.

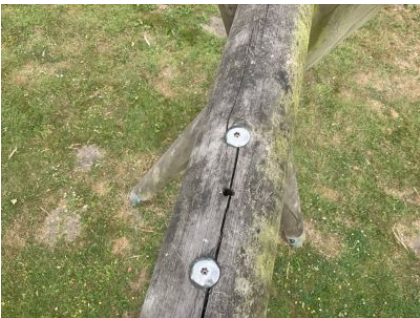
There are natural splits / shakes in the timbers.

Monitor for decay forming within the shakes on the crossbar.

Monitor and sand back any splintered edges as required., DO NOT fill shakes.  
There are shakes running through fixing points. Ensure the fixings are fully secure on regular basis.

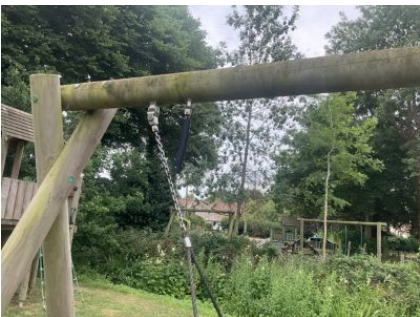
Chain covers prevent a thorough inspection of all chain links.

Remove chain covers to inspect according to manufacturer's instructions.

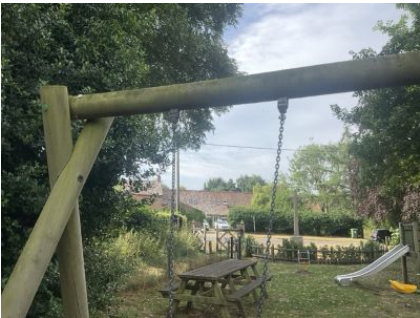
Bolt(s) loose.

Swing hanger bolts are loose on the crossbar.

Tighten.

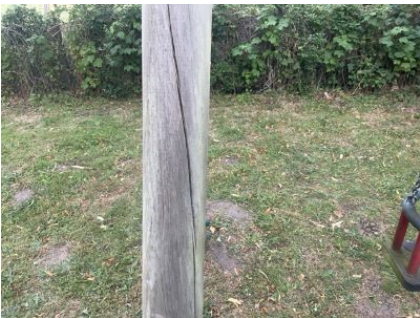
There are natural splits / shakes in the timbers.

Monitor and sand back any splintered edges as required.

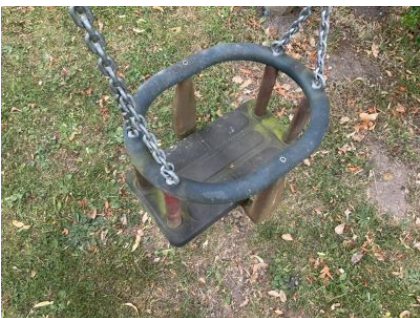
The equipment is dirty or algae covered.

Clean off.

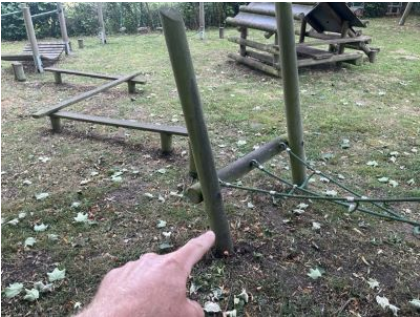
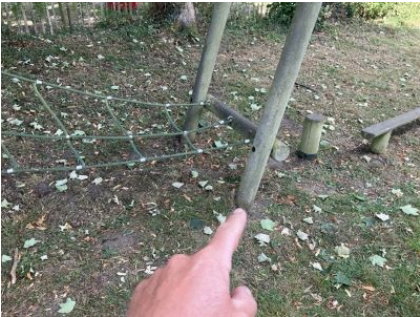
Timber is decayed.

Net support x 1 rotten through at ground level and cracking when load tested.  
Adjacent post also showing signs of decay below ground level.

Replace affected parts.

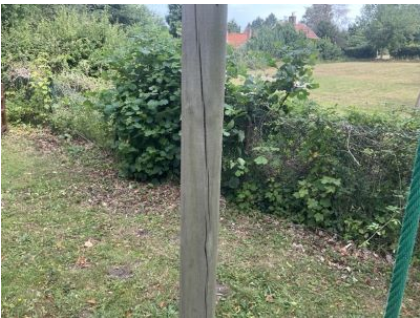
There are natural splits / shakes in the timbers.

Monitor and sand back any splintered edges as required., There are shakes running through fixing points. Ensure the fixings are fully secure on regular basis.

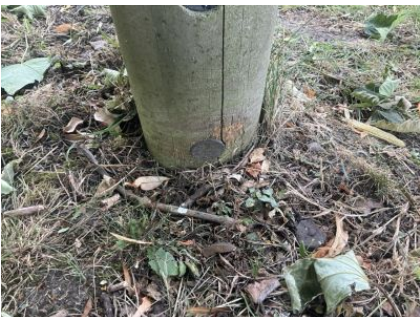
Strimmer damage is present on posts, allowing water to enter and timbers to soften. It can also remove the protective envelope around the timber. Prevent further damage and check timbers for decay throughout the year.

Prevent further damage.

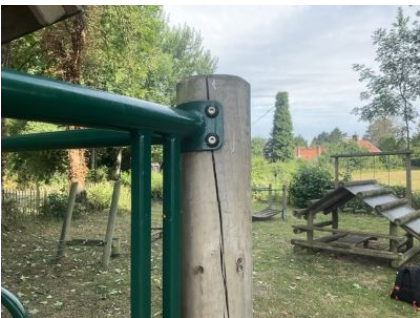
There are natural splits / shakes in the timbers.

Monitor and sand back any splintered edges as required., There are shakes running through fixing points. Ensure the fixings are fully secure on regular basis.

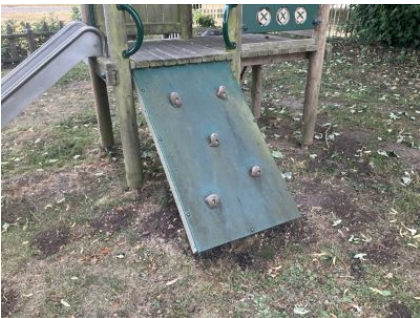
The equipment is dirty or algae covered.

Clean off.

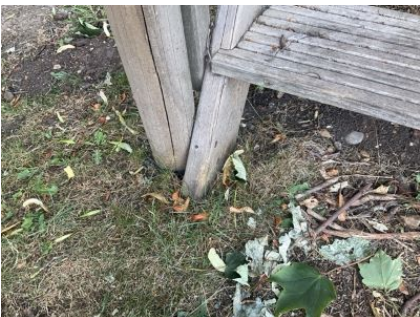
Strimmer damage is present on posts, allowing water to enter and timbers to soften. It can also remove the protective envelope around the timber. Prevent further damage and check timbers for decay throughout the year.

Prevent further damage.

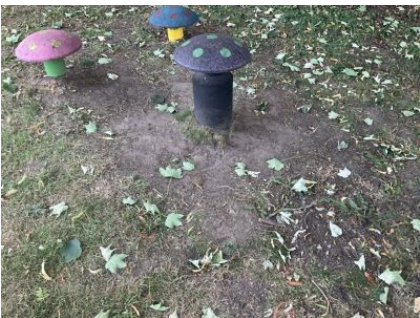
Surface is wearing.

Monitor for significant deterioration and rectify when necessary.

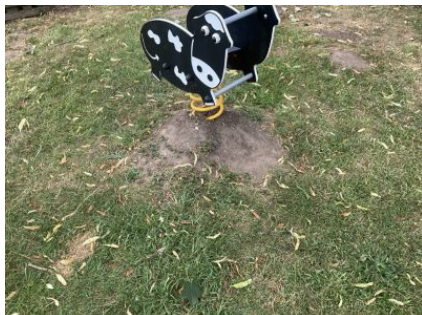
| Description | Tasks | Risk score |
|---|---|---|
| Surface is uneven. | Make good. | 5 |

Level of ground and repair.

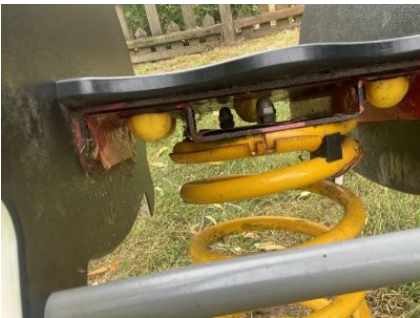
Paintwork is in poor condition.

De-scale back to good base material and coat with lead free paint, using appropriate precautions. Repairs may be necessary where corrosion is severe.

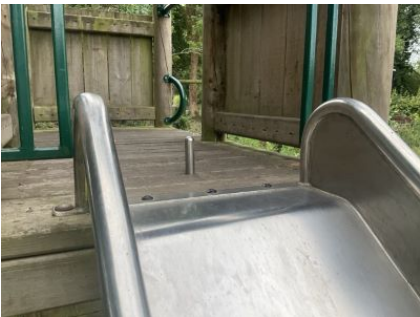
| Description | Tasks | Risk score |
|---|---|---|
| Finger entrapment. | Eliminate the entrapment. | 5 |

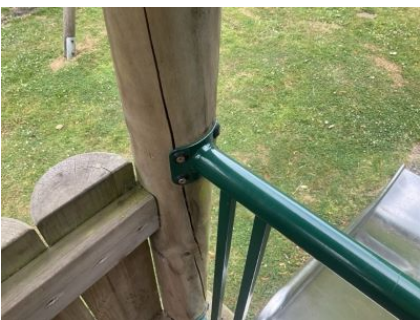
| Description | Tasks | Risk score |
|---|---|---|
| There are natural splits / shakes in the timbers. | Monitor and sand back any splintered edges as required., There are shakes running through fixing points. Ensure the fixings are fully secure on regular basis. | 6 |

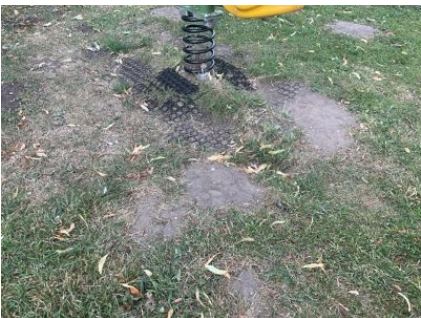
| Description | Tasks | Risk score |
|---|---|---|
| Surface is uneven. | Make good. | 6 |

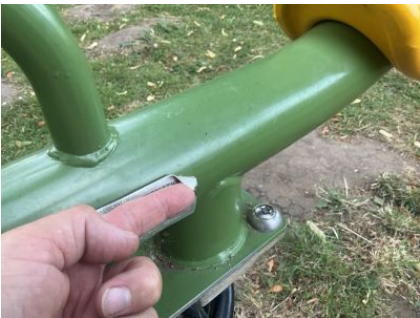
| Description | Tasks | Risk score |
|---|---|---|
| Hard or sharp projections. | Remove hard, pointed and sharp projections. | 6 |
