# Safety Inspection Report

Annual Inspection

## Church View Play Area

Stibbard Parish Council

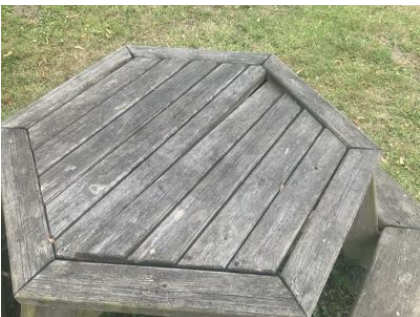
| Minor repairs are needed. |
| Table slats are loose. |

| Repair. |

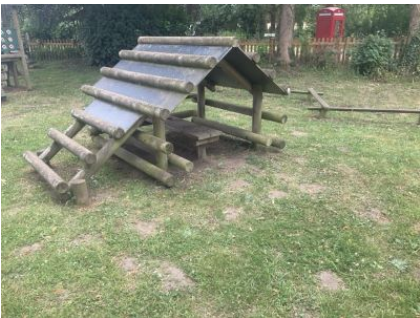
Suitably well maintained grass and topsoil with at least 150 mm of soil beneath is acceptable to EN 1176 for items with a fall height of up to 1.5 metres, subject to a risk assessment.

Monitor to maintain the grass in good condition.

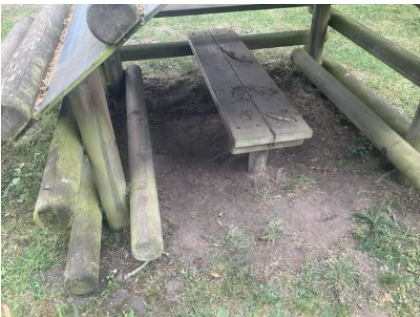
Worn ground areas.

Read the notes for further action.

Repair worn areas and consider installing a harder wearing surface.

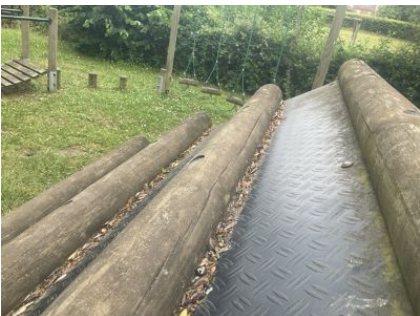
There are natural splits / shakes in the timbers.

Shakes vary. Monitor and consult manufacturer if dimensions exceed 8 mm at sections used to grip / grasp., DO NOT fill shakes. Monitor and sand back any splintered edges as required.

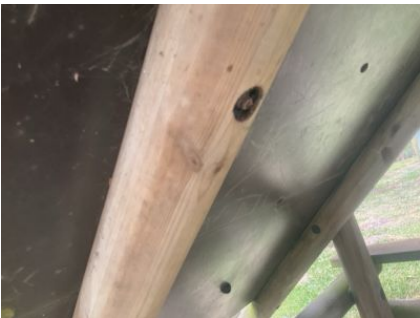
Cap missing.

Replace.

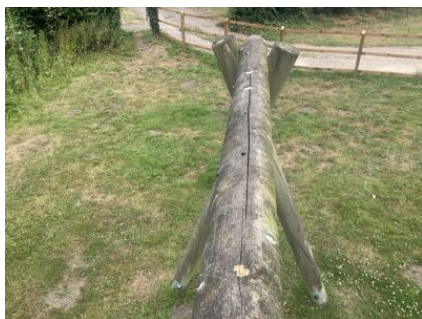
There are natural splits / shakes in the timbers.

Monitor for decay forming within the shakes on the crossbar. No signs of decay at the time of inspection.

Monitor and sand back any splintered edges as required., DO NOT fill shakes.  
There are shakes running through fixing points. Ensure the fixings are fully secure on regular basis.

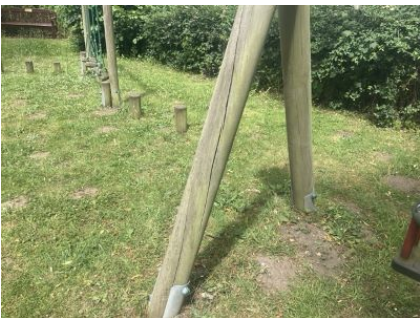
There are natural splits / shakes in the timbers.

Monitor and sand back any splintered edges as required.

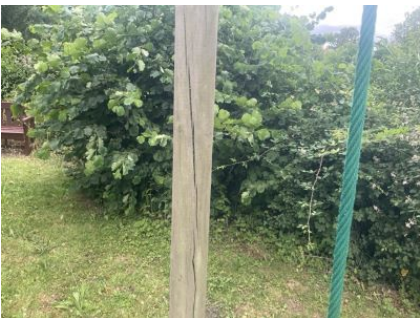
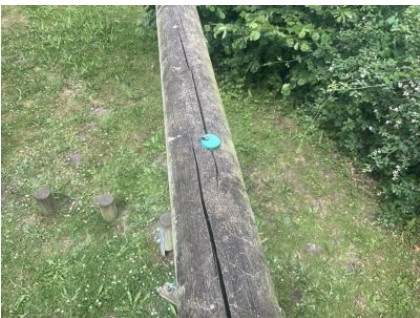
There are natural splits / shakes in the timbers.

Monitor and sand back any splintered edges as required., There are shakes running through fixing points. Ensure the fixings are fully secure on regular basis.

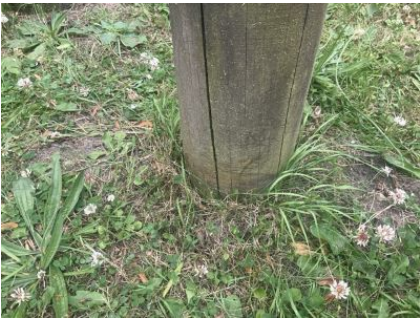
Strimmer damage is present on posts, allowing water to enter and timbers to soften. It can also remove the protective envelope around the timber. Prevent further damage and check timbers for decay throughout the year.

Prevent further damage.

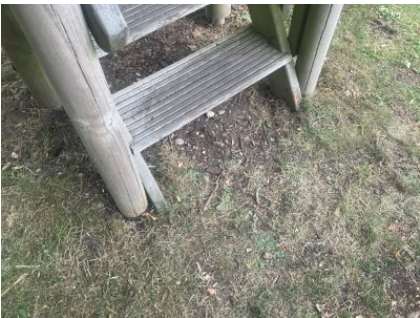
Strimmer damage is present on posts, allowing water to enter and timbers to soften. It can also remove the protective envelope around the timber. Prevent further damage and check timbers for decay throughout the year.

Prevent further damage.

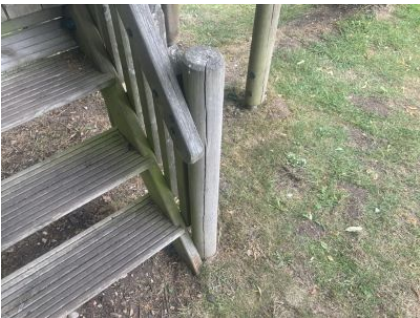
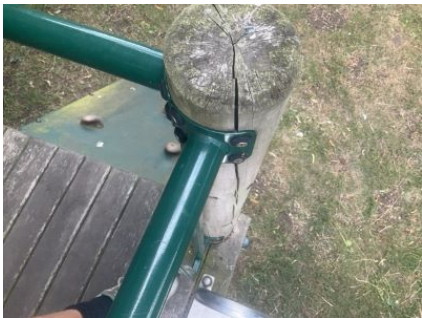
There are natural splits / shakes in the timbers.

Monitor and sand back any splintered edges as required., There are shakes running through fixing points. Ensure the fixings are fully secure on regular basis.

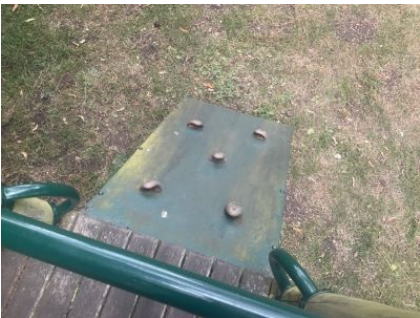
The equipment is dirty or algae covered.

Clean off.

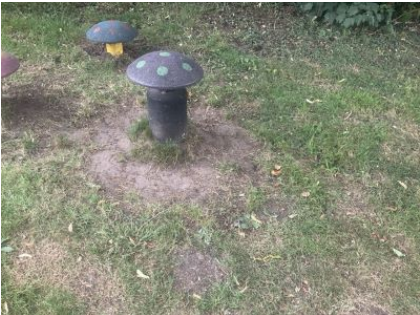
Surface is wearing.

Read the notes for further action.

Consider installing a harder wearing safer surface below the revolving mushroom to help with erosion.

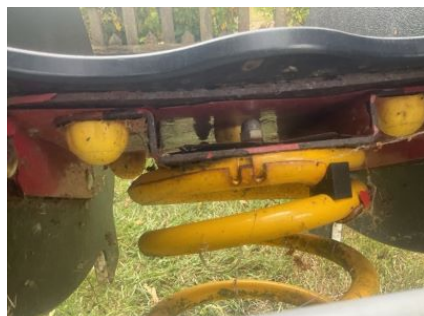
Paintwork is in poor condition.

Seat framework corroding.

De-scale back to good base material and coat with lead free paint, using appropriate precautions. Repairs may be necessary where corrosion is severe.

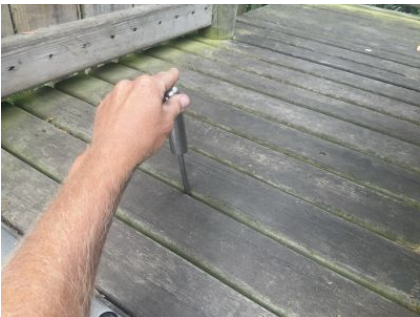
Finger entrapment.

Finger entrapment in the floor panel at the top of the slide.

Eliminate the entrapment.

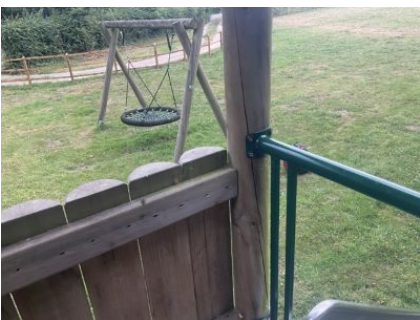
There are natural splits / shakes in the timbers.

Monitor and sand back any splintered edges as required., There are shakes running through fixing points. Ensure the fixings are fully secure on regular basis.

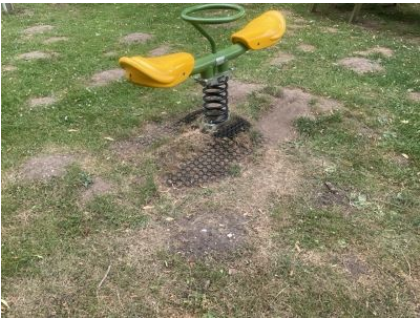
Surface is uneven.

| Description | Tasks | Risk score |
|---|---|---|
| Surface is uneven. | Make good. | 6 |
